INSPECTION REPORT: KENSINGTON GOLD MINE

Tongass National Forest Minerals Group
8510 Mendenhall Loop Rd
Juneau, AK 99801
(907) 789-6275– office
(907) 586-8808 – fax

Date of Inspection: Wednesday October 16, 2019
Date of Report: Wednesday October 23, 2019
USDA Forest Service Inspector: Richard Dudek

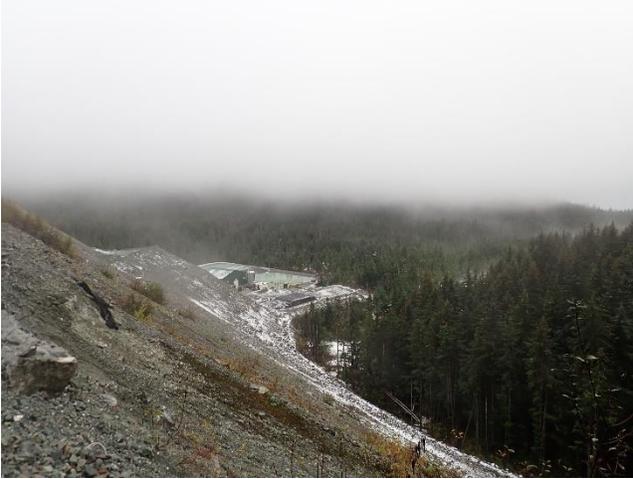
Waste rock from the Raven drift is currently being deposited at this location (Photo 1).

Photo 1. Comet development pile.

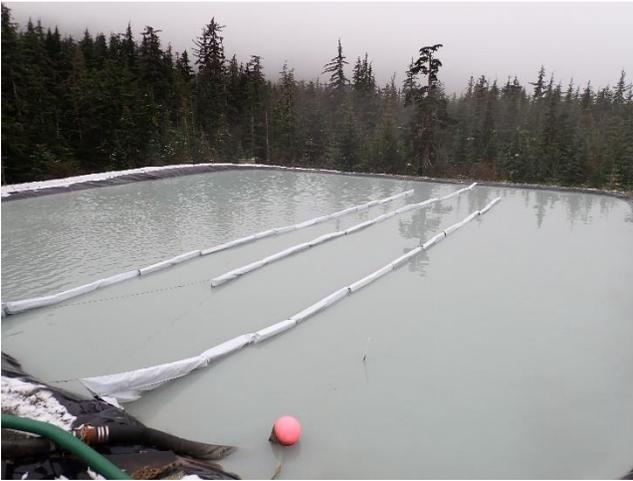
On 10/16/2019, the CWTP was treating 1,540 gallons per minute (gpm). The silts curtains were restaged to help localize sediments discharging into pond 1 (Photo 2). Pond 2 was receiving back wash from the treatment plant (Photo 3).

Photo 2. Pond 1.

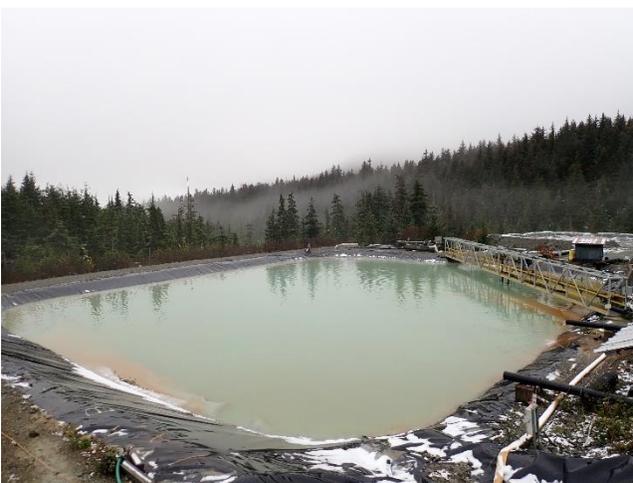
Photo 3. Pond 2

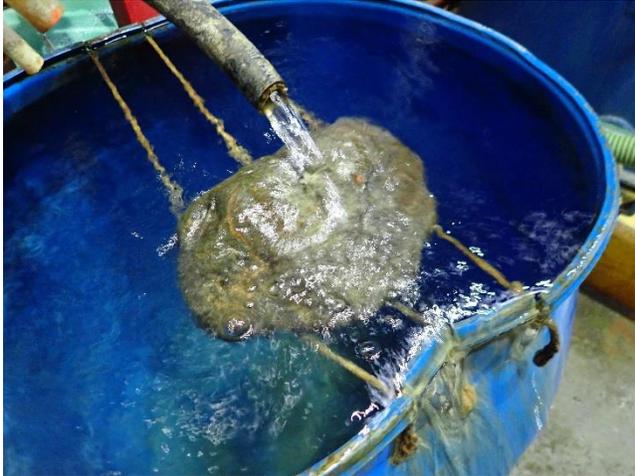
There was no white material observed on the clean test rock used for monitoring its accumulation (Photo 4). The Comet water treatment plant operators continue to use calcium chloride (CaCl_2) to help remove white material out of solution.

Photo 4. The white material test rock.

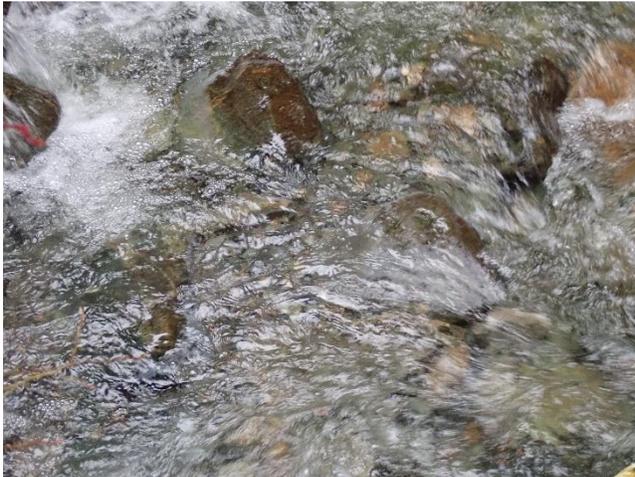
White material was observed on rocks throughout the creek bed (Photos 5-6).

Photo 5. White material was observed adhering to rocks in the creek bed.

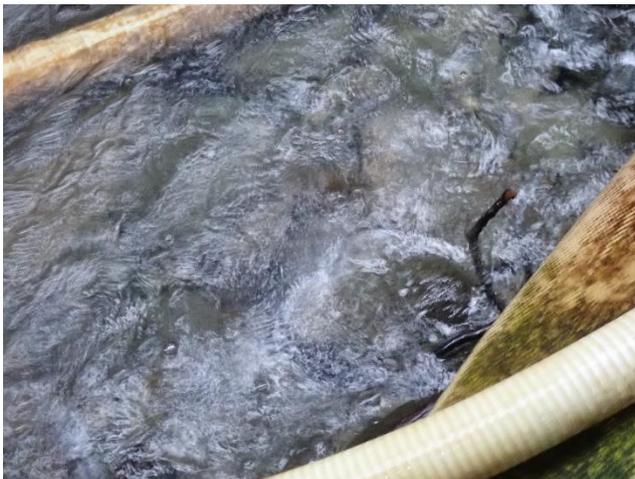
Figure 6. White material adsorbing to rocks.

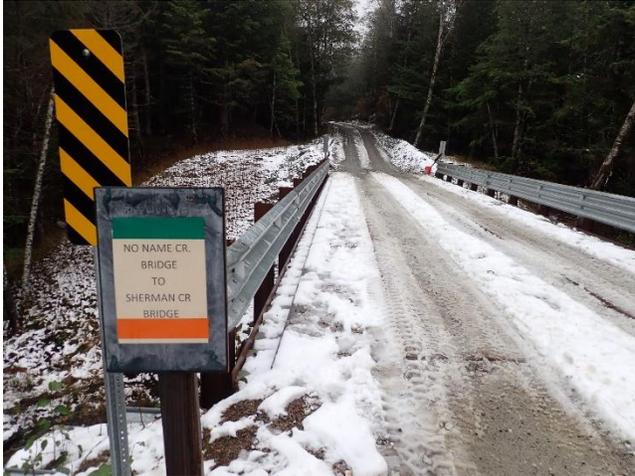
New silt fencing has been installed along the abutments of both bridges (Photos 7-10).

Photo 7. No Name Creek Bridge.

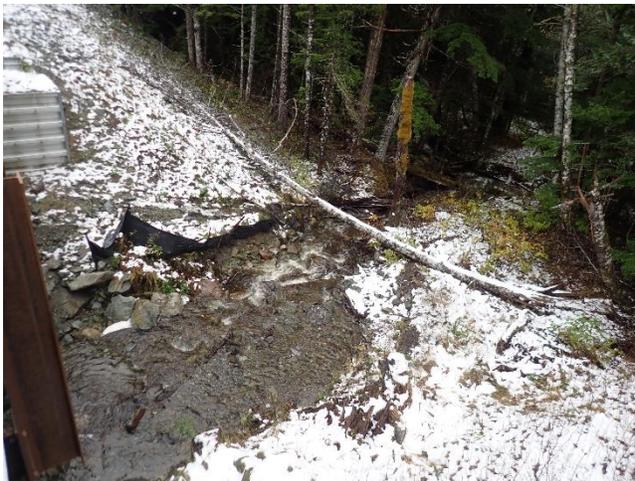
Photo 8. Silt fencing restaged along the bridge abutment.

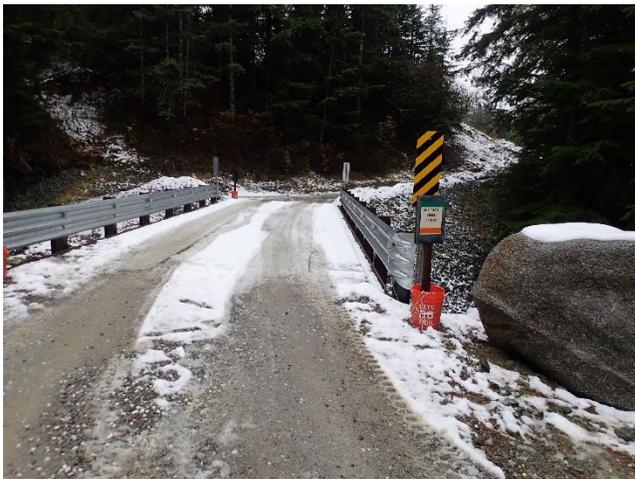
Photo 9. Sherman Creek Bridge.

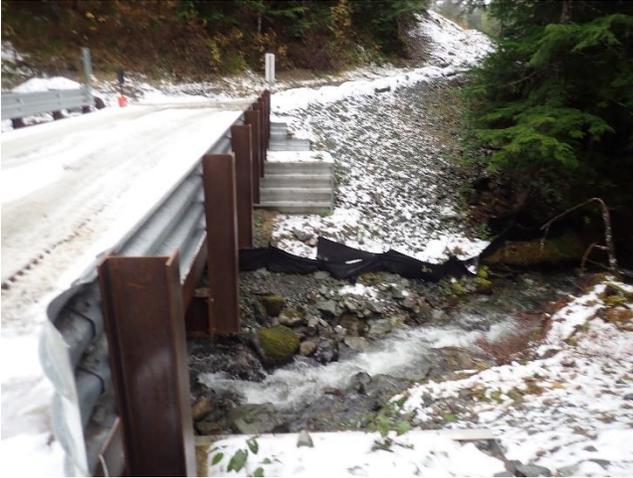
Photo 10. Silt fencing is in place to prevent debris from entering the stream.

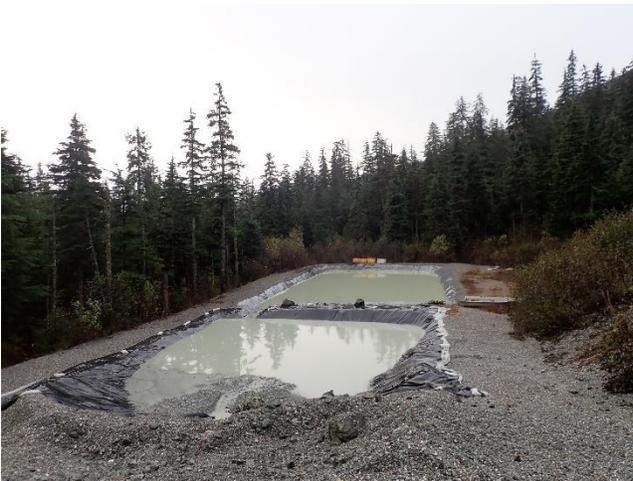
The settling pond at this location was working as intended (Photo 11).

Photo 11. The warehouse settling pond.

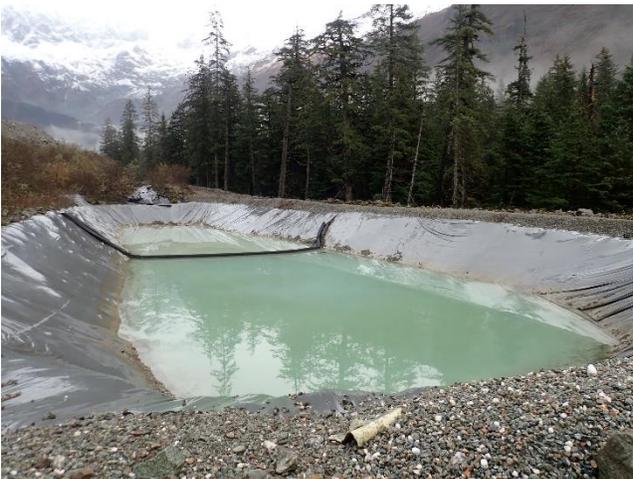
The settling pond for this location is functioning as intended (Photo 12).

Photo 12. The avalanche pond.

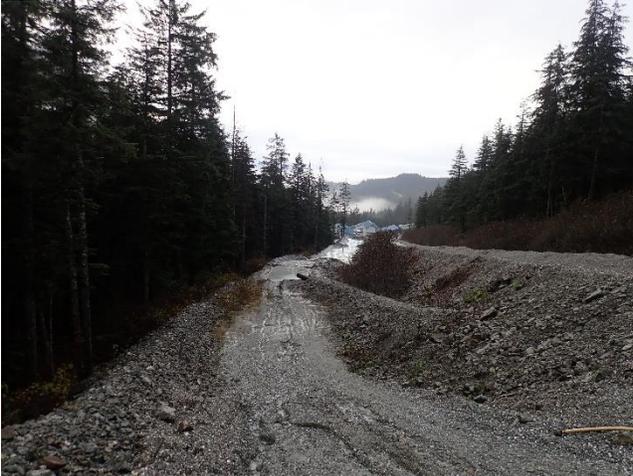
All three ponds were working as intended (Photos 13-14).

Photo 13. The water bar settling ponds.

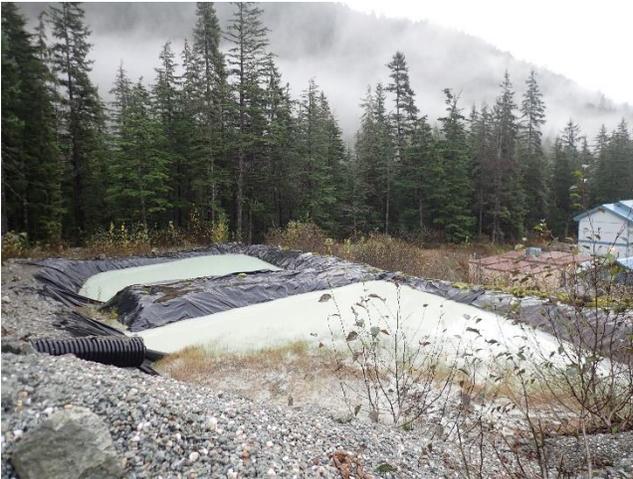
Photo 14. The lower water bar settling pond.

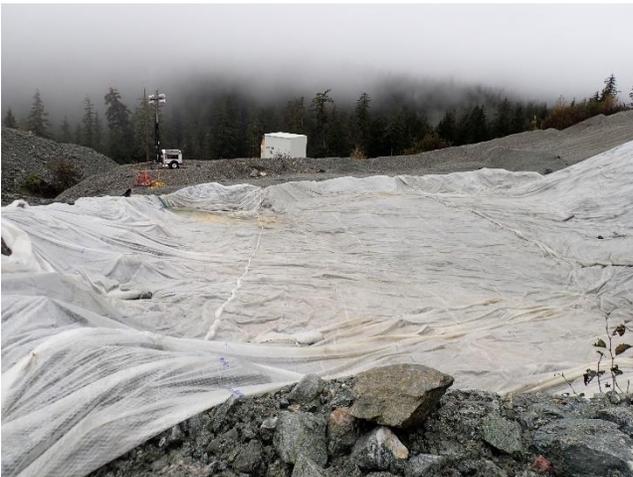
Coeur personnel continue to use the graphitic phyllite (GP) stockpile (Photo 15) staged at pit 4 for GP/cement underground backfill. The year to date for GP/cement mix is approximately 12,100 tons. Some waste rock from this location (Photo 16) is currently being relocated to Pit 1 (Photo 17) for a construction contractor. The contractor will eventually ship the material offsite.

Photo 15. The GP stockpile currently being used for the GP/cement mix.

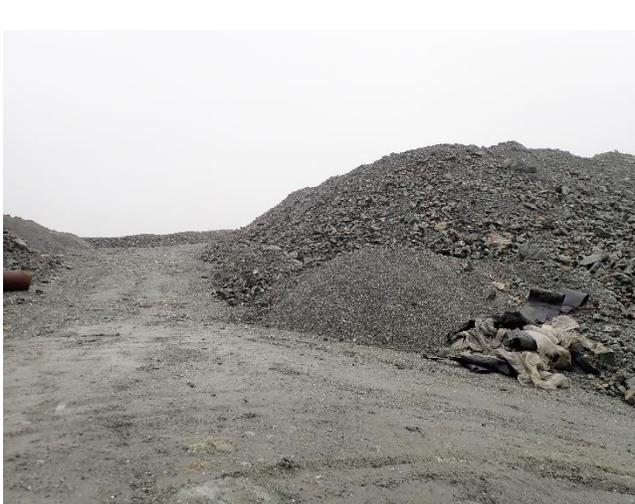
Photo 16. Waste rock staged at Pit 4.

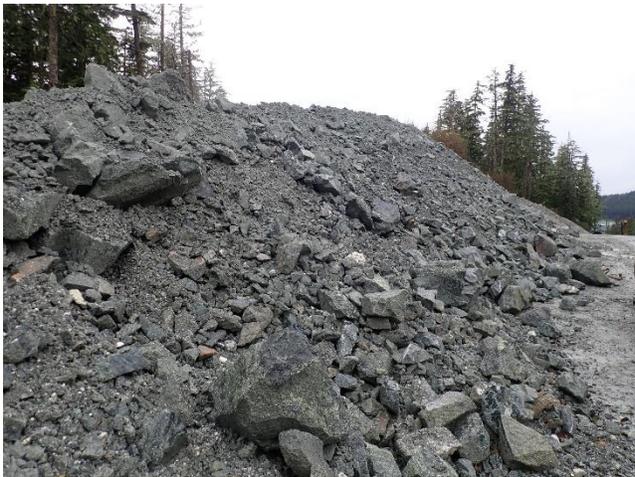
Photo 17. Waste rock from Pit 4 is being staged at Pit 1 for a construction contractor.

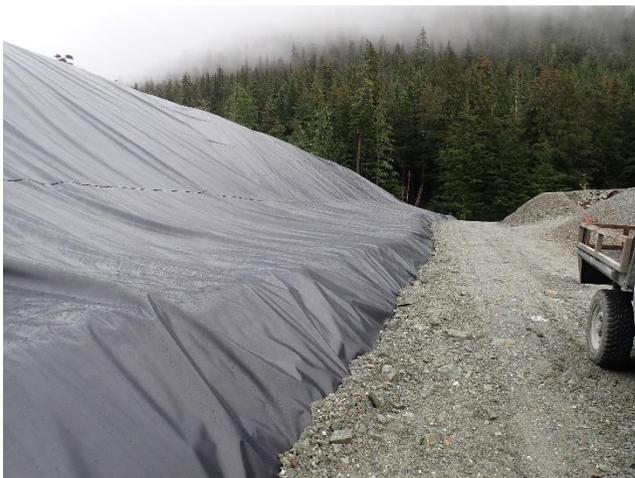
Surface Operations recently placed an additional HDPE liner over the original liner because stormwater was able to get underneath the first liner (Photo 18). The stormwater was pumped out prior to the new liner being placed over the stockpile (Photo 19).

Figure 18. The mud dump HDPE lined GP stockpile.

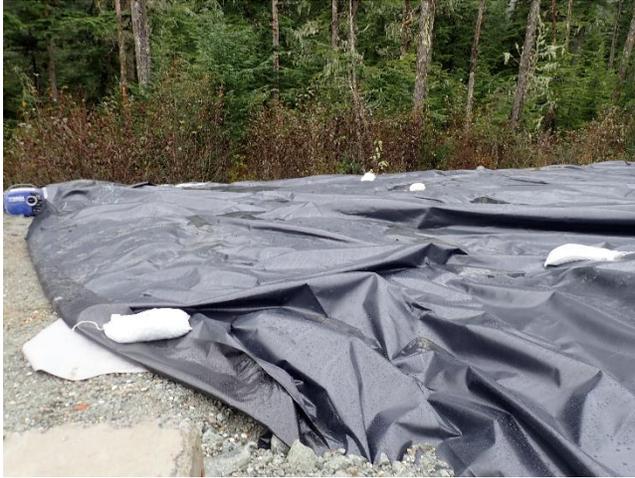
Photo 19. The south-west section of the GP stockpile where stormwater had accumulated.

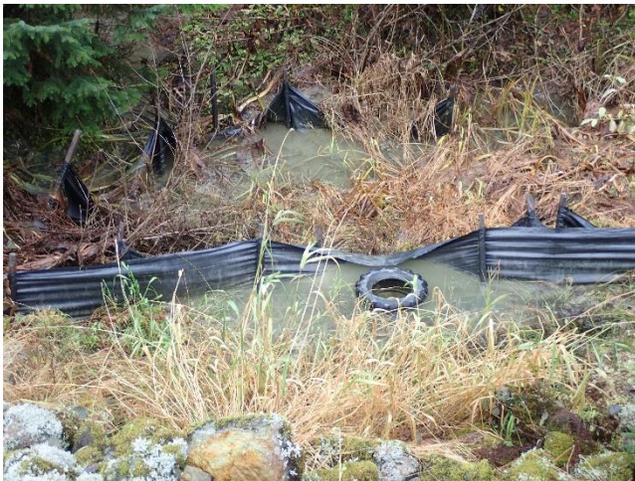
Photo 20. A small tire needs to be removed and the secondary silt fencing needs to be repaired.

A small tire needs to be removed from the base of the second settling pond (Photo 20). Sections of the secondary silt fencing needs to be repaired and/or replaced. The maintenance for silt fencing is to repair the deficiencies (i.e. sagging, torn, punctured fabric) immediately (Appendix 4g; page C-12).

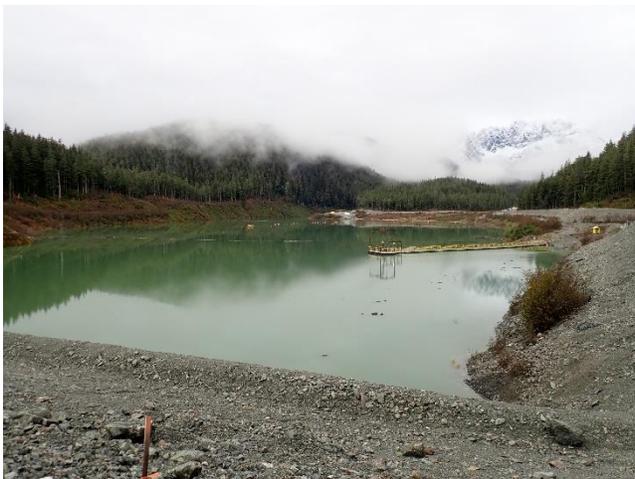
The TTF's recorded water level on 10/16/2019 was 706.1 feet (Photo 21). The tailings barge has been moved central area of the TTF.

Photo 21. The TTF or Lower Slate Lake.

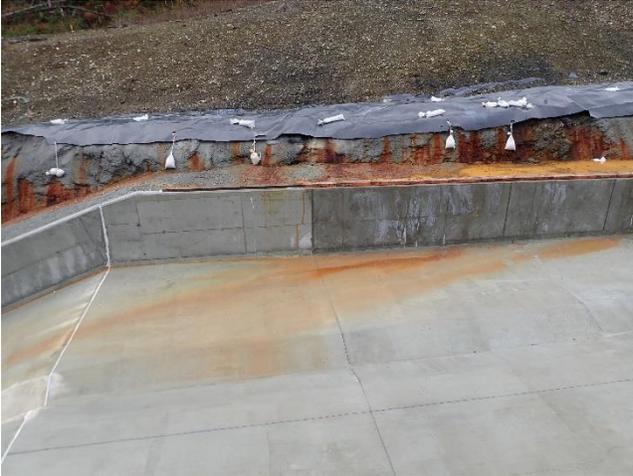
The five corrective actions taken to mitigate the acid rock drainage (ARD) in the dam spillway (Photo 22) are as follows:

Photo 22. The south-west side of the TTF dam spillway.

1. Coeur Alaska personnel enlarged the ARD seepage conveyance ditch to the ARD seepage collection sump.

2. Coeur Alaska personnel installed four 4" x 6" boards on top of the wall. The bottom of the boards were sealed to prevent ARD from seeping underneath and/or around the boards.
3. The four boards were cemented to create an improved curb to help prevent ARD from flowing into the spillway.
4. The ARD stained wall was covered with cement for visually identifying future ARD seepage.
5. An HDPE liner above the cut slope was reestablished to divert stormwater away from the cut slope and minimized the potential for ARD generation.

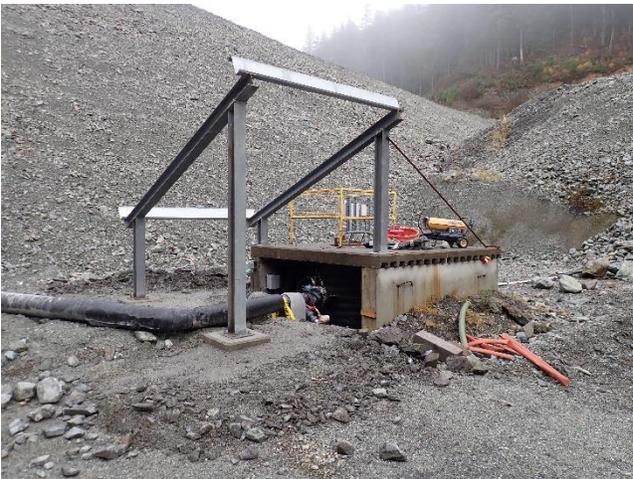
Below the dam, Coeur Alaska personnel are in the process of constructing a roof over the dam pump back station (Photo 23).

Photo 23. Coeur personnel have started construction for roof over the dam pump back station.

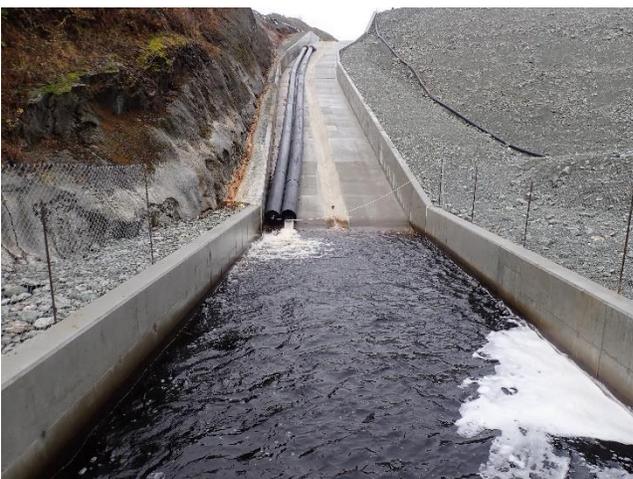
The dam spillway and the effluent spillway were functioning as intended (Photos 24-25).

Photo 24. The TTF dam spillway.

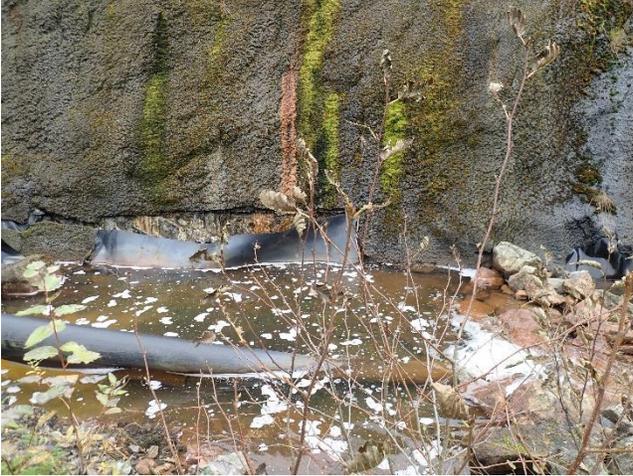
Photo 25. The TTF effluent spillway.

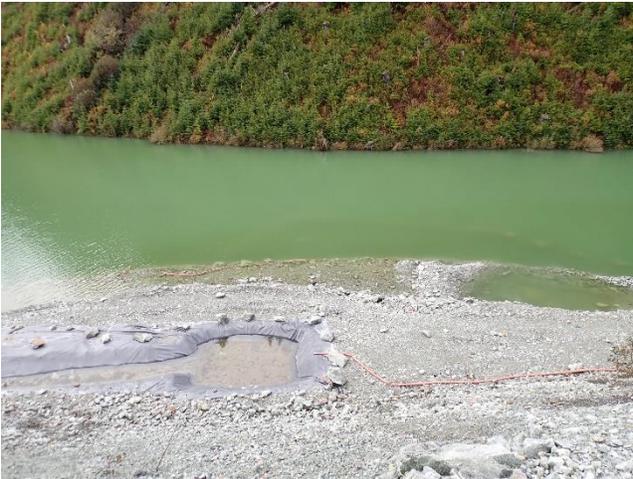
No ARD plumes were observed in the northern TTF area (Photo 26).

Photo 26. The northern TTF area.

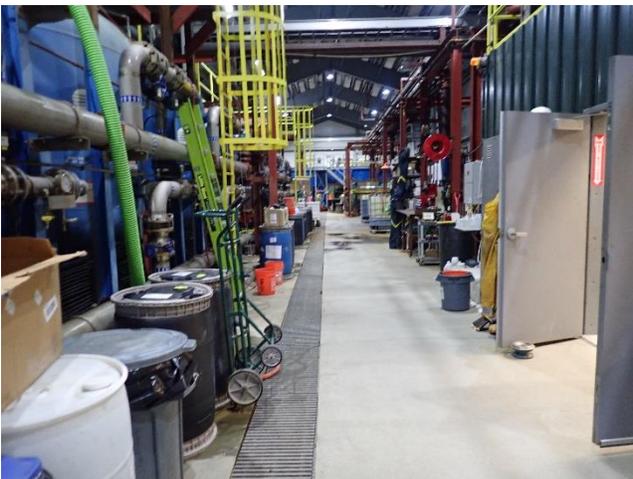
"Good housekeeping" practices were observed at the TTF water treatment plant ((Photo 27) (Appendix 4g BMP Plan; Table 4-1)).

Photo 27. The TTF water treatment plant.

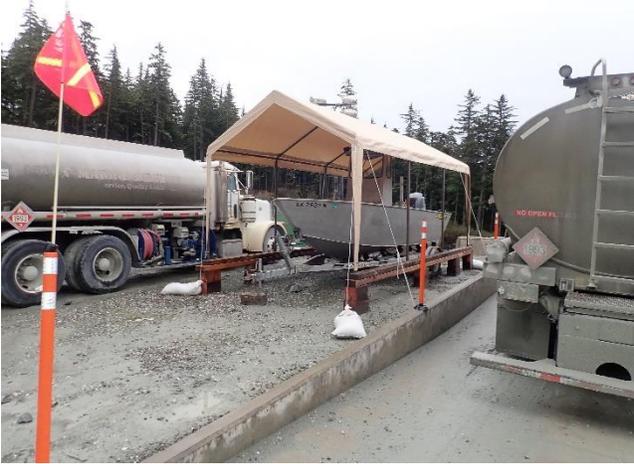
The fuel depot was tidy and in order (Photos 28-31). There were no spills or fuel sheen observed at this location.

Photo 28. The fuel depot skiff is now covered.

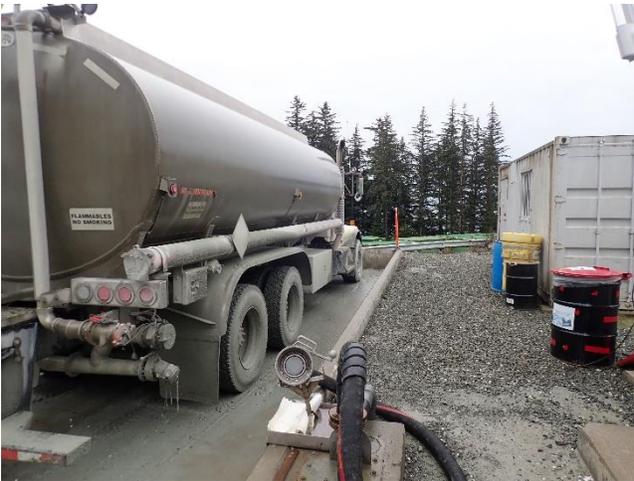
Photo 29. Concrete refueling station.

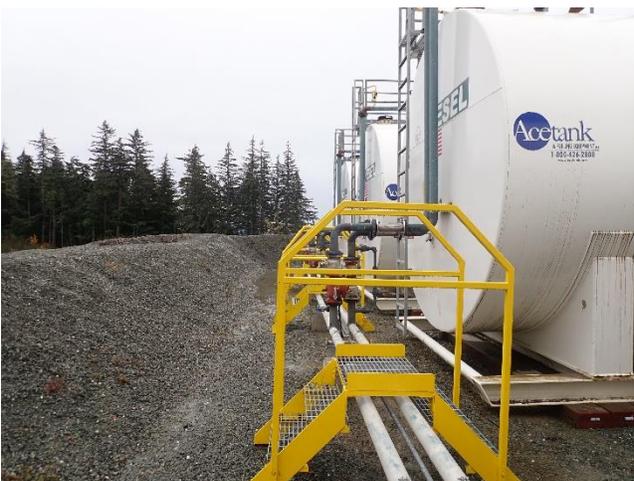
Photo 30. The fuel depot tanks 1, 2 and 3.

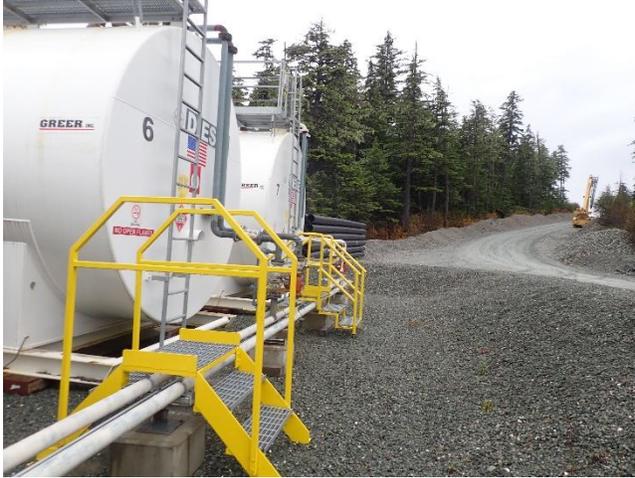
Photo 31. The fuel depot tanks 6 and 7.
